AFWAL-TR-82-2043

MATERIALS SCREENING TESTS OF THE FOD IMPACT  
DESIGN TECHNOLOGY PROGRAM (TASK IV C)

University of Dayton Research Institute  
Dayton, Ohio 45469

Interim Report for Period 1 October 1977 - 1 June 1980

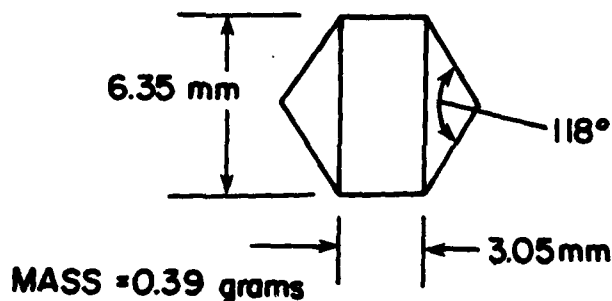
Figure 1. Shape of Granite Pebble

In the testing, the impact angle was held normal ( $90^\circ$ ) and three impactors were used in the testing. A 0.5 inch (1.27 cm) diameter micro-balloon gelatin sphere with 10 percent porosity was utilized on all six materials. The remaining two impactors were 1.27 cm diameter ice balls and 0.63 cm diameter "standard" pebble. The pebble material was granite which was machined to the cone-cylinder-cone shape shown in Figure 1. The mass of the substitute birds was approximately 0.98 grams, 0.97 grams for the ice balls, and 0.39 grams for the pebbles.

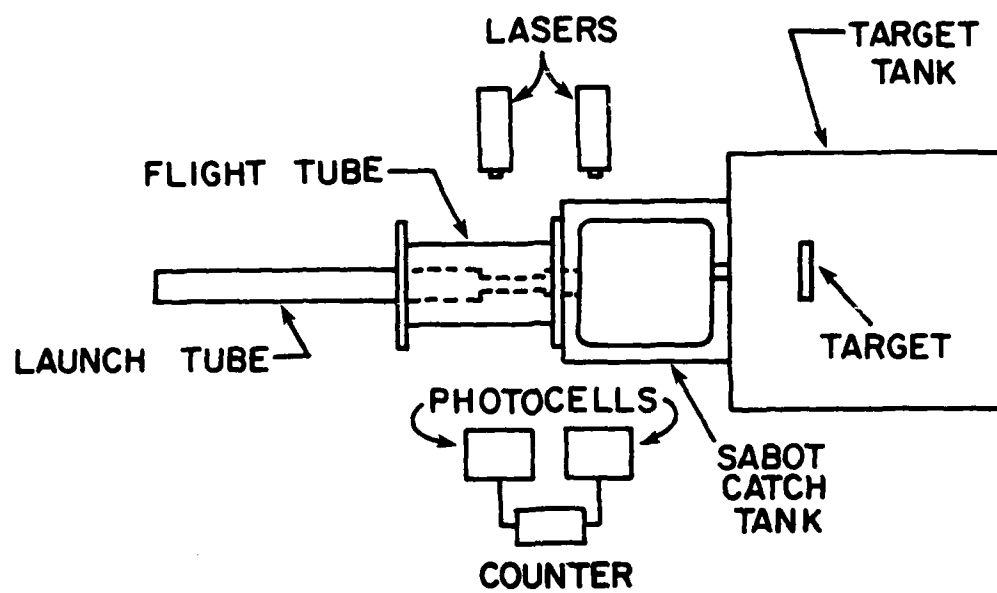
Figure 2. Schematic of Range Set-Up

A schematic of the range set-up used in the ballistic limit testing is shown in Figure 2. The range set-up consisted of a launch tube, velocity measuring system, sabot catch tank, and a target tank with a mounting fixture. For the 0.63 cm pebble impacts, the launch tube had a smooth bore of 12.7 mm and a length of 1.83 m. The launch tube for the 1.27 cm diameter birds and ice balls was a smooth bore of 20.0 mm having a length of 2.13 m. The projectiles to be fired were positioned into a recessed pocket of a lexan sabot to provide protection and support for the particles during launch. The projectiles/sabot package was launched down the tube by utilizing either compressed gas or powder gas depending on the desired impact velocity. Compressed gas was used for impact velocities up to 305 m/s. Above 305 m/s a powder gun was used. A sabot stopper device was located

at the muzzle of the launch tube. The purpose of this device was to slow down and eventually stop the sabot, permitting the projectile to separate from the sabot and continue on trajectory towards the target specimen.

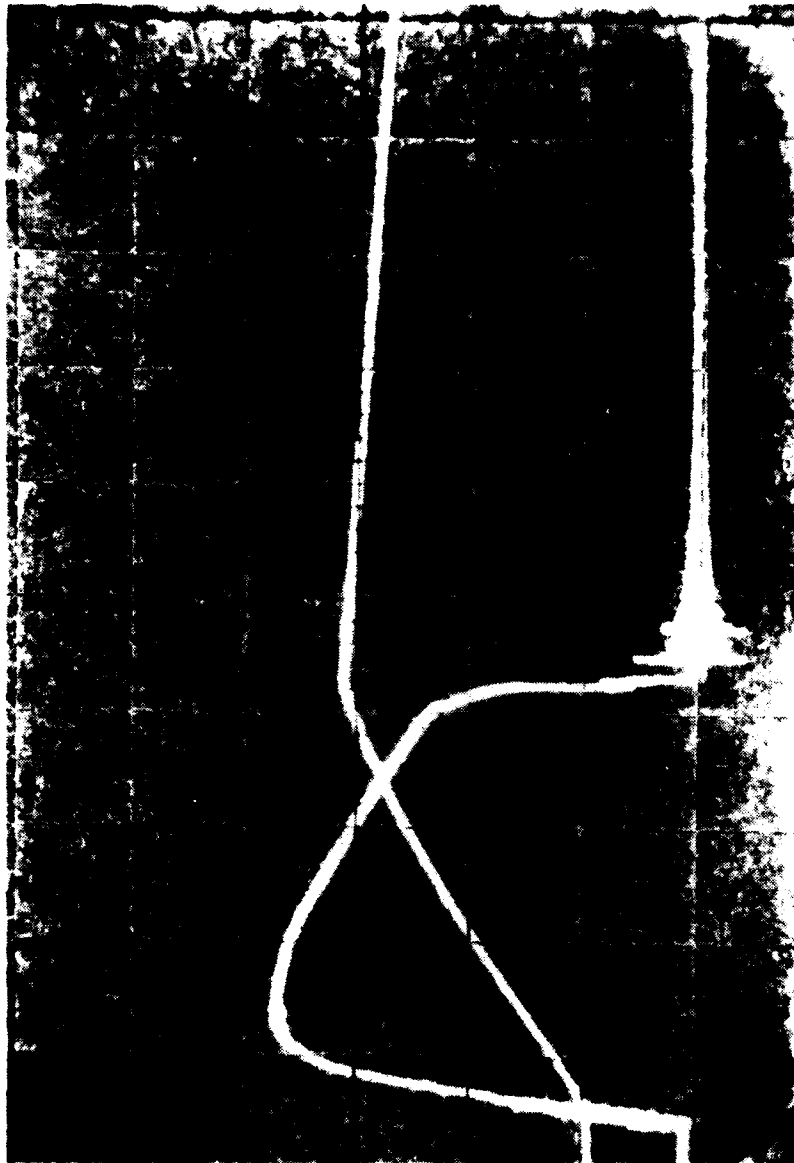
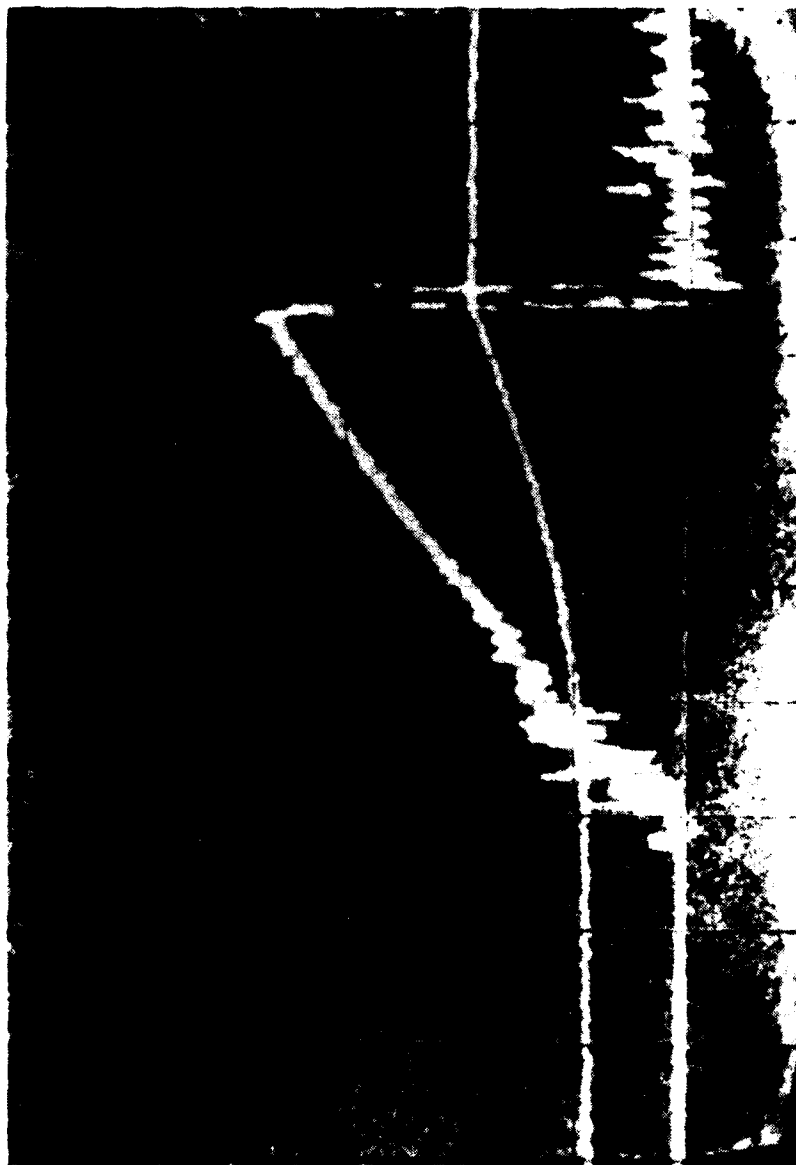
The ranking of the materials was achieved by calculating the average peak force and peak energy levels of

Figure 14. Typical Charpy Impact Test Results on  
8-1-1 Titanium Material

Figure 15. Typical Charpy Impact Test Results on Boron/Aluminum Material

The resulting peak force and energy rank values were then averaged to give an overall ranking of the materials which is given in the third column of Table 8. Using this method, the 8-1-1 titanium material was the best material with a rank of ten followed by the 6-4 titanium with a rank of 9.05. The 410 stainless steel in the heat-treated condition has a rank of 8.75 followed by the graphite/epoxy and annealed stainless steel materials with a rank of 4.3. The worst material was the boron/aluminum with rating of 2.65

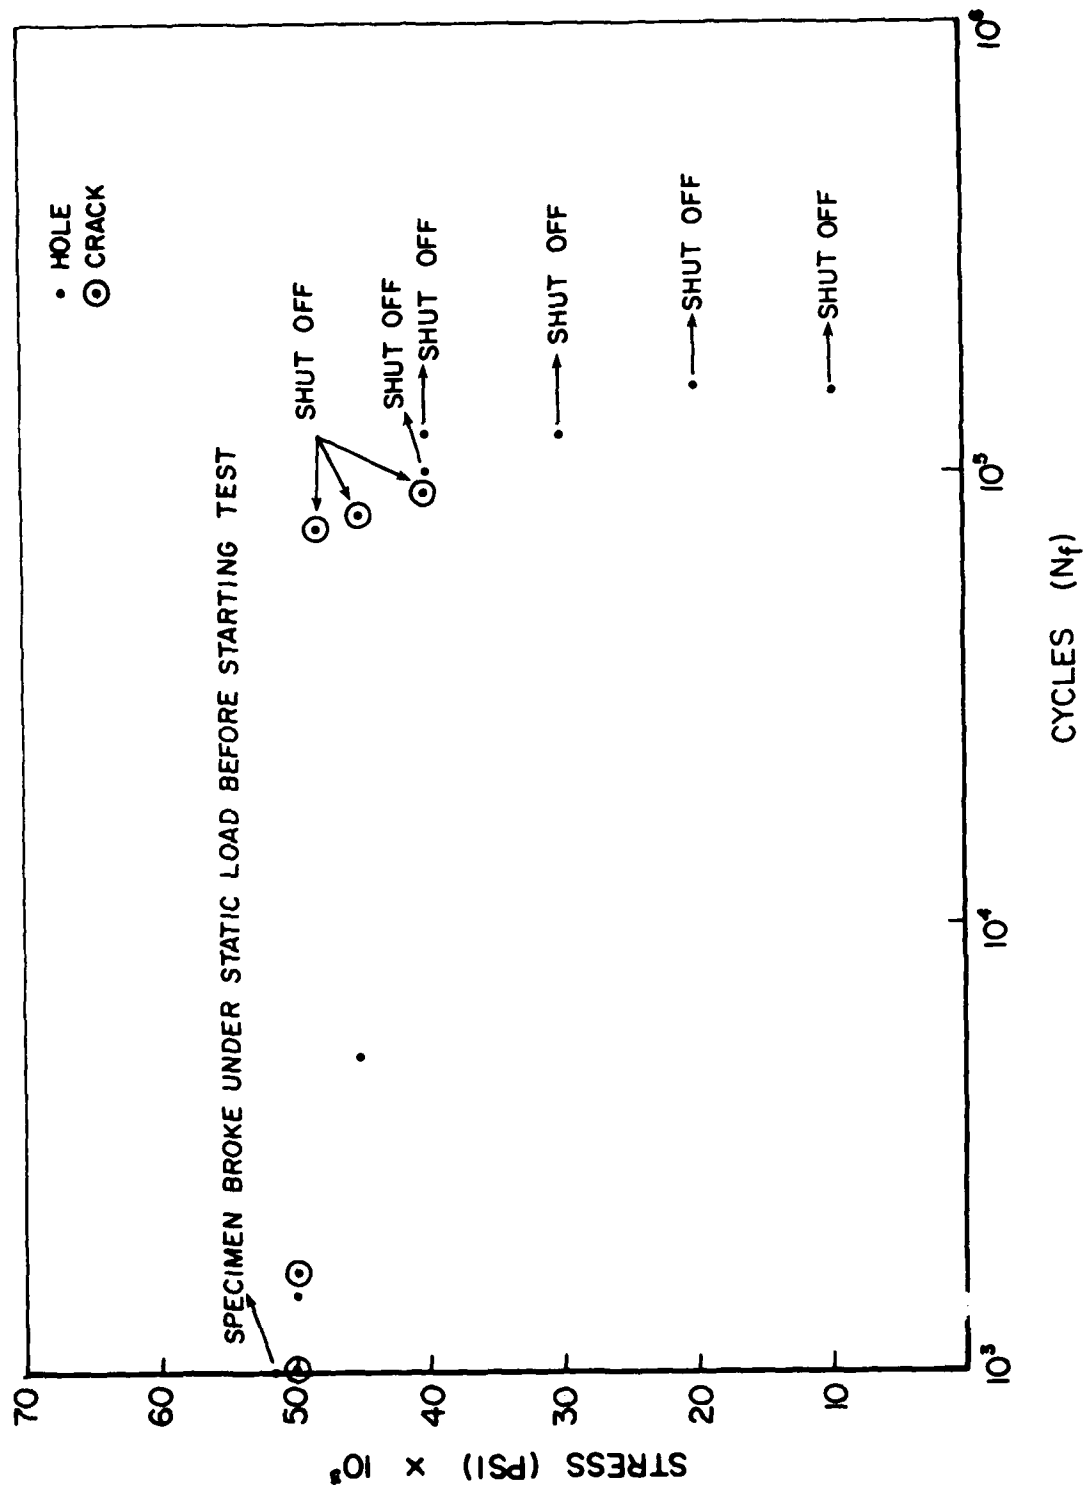
Figure 17. Fatigue Results for Boron/Aluminum Composite Specimens

Figure 17 gives the results of the testing for the boron/aluminum composite material. Again, as was the case for the graphite/epoxy, the boron/aluminum appeared to be insensitive to fatigue at the lower stress levels. At a stress level of approximately 50 ksi, the specimens would not fail at the high level of  $10^5$  cycles and greater. In one case, one of the composite specimens failed at a static load of about 52 ksi before starting the test. Based on these results, the two composite materials appear to not have a fatigue problem when loaded in tension.

The boron/aluminum material had a constant stress level of 50 ksi for both cycle levels and specimen types. Based on the ranking system, the rank for the crack specimens is 5.3 and 5.5 for the hole specimens.

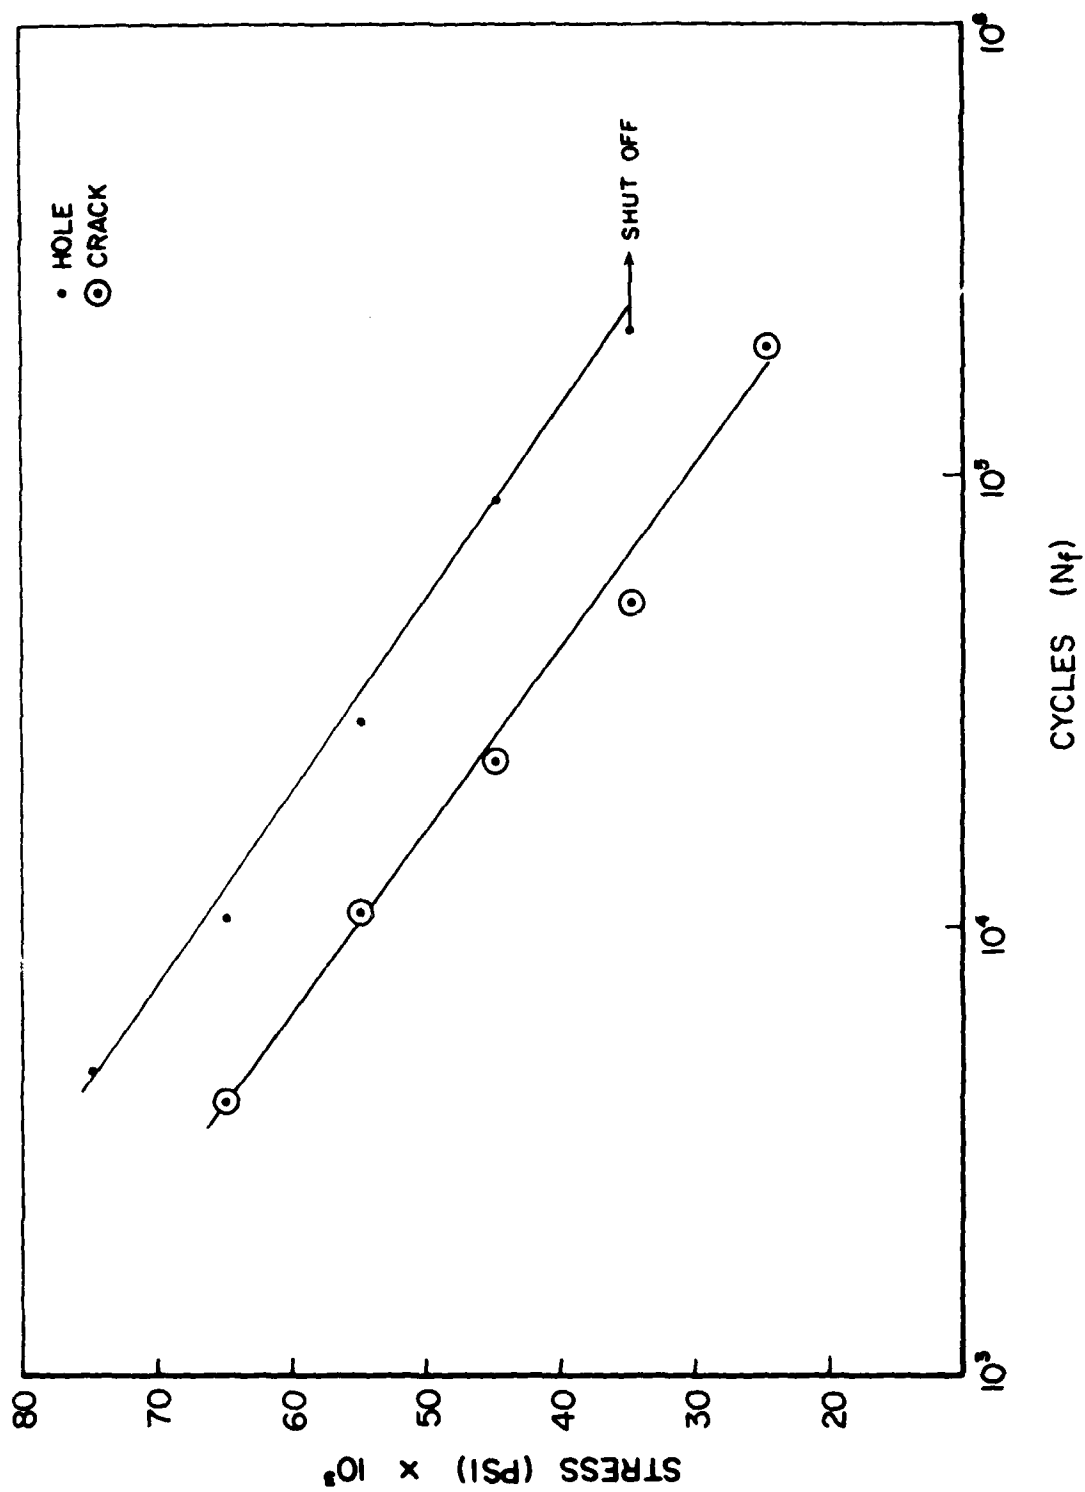
Figure 18. Fatigue Results for 410 Stainless Steel (Annealed) Specimens

The fatigue results for the 410 stainless steel in the annealed condition is shown in Figure 18. As expected, the curve for the machined crack specimens is lower by about 12 ksi than for the machined hole specimens for similar cycle values. The slope of the curves for the machined crack and hole specimens was very similar.

The 410 stainless steel material in the annealed condition did not fare too well in the fatigue tests and received the lowest rating for the metal materials. For the  $10^4$  cycle value, the material had a stress level of 55 ksi for the specimens with a crack and a level of 57 ksi for the specimens with a hole. For the  $10^5$  cycle value, stress levels of 31 and 44 ksi were received for the crack and hole specimens, respectively. Using the ranking system, ratings of 4.6 and 6.1 were received for the crack and hole specimens, respectively.

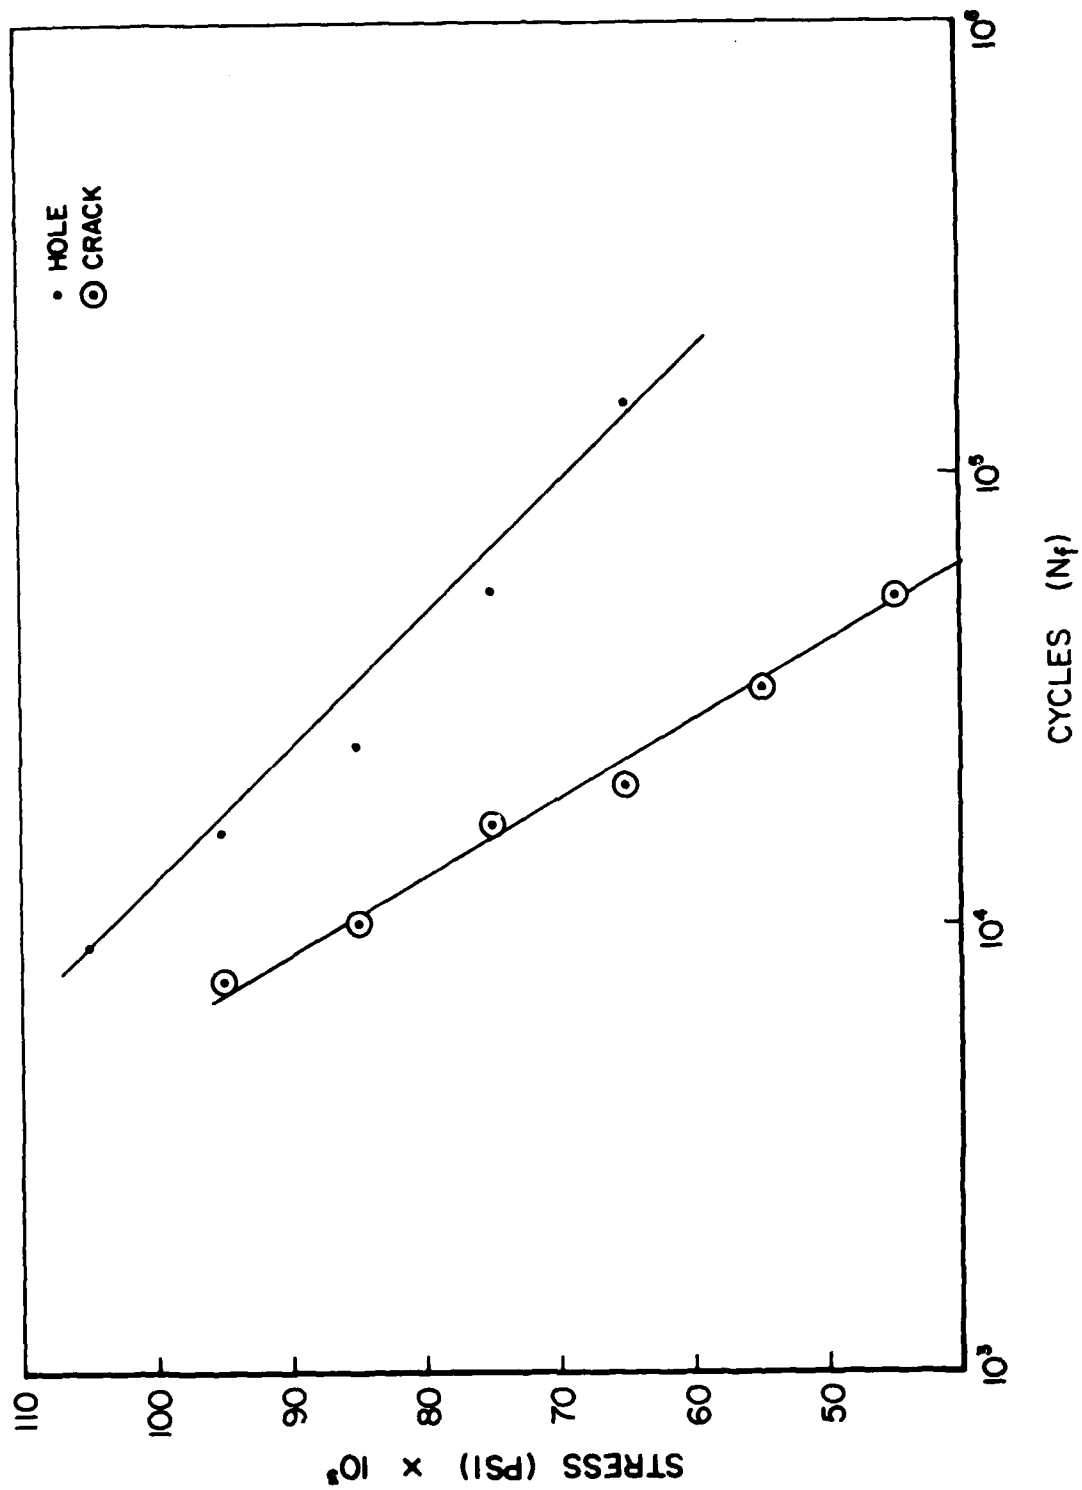
Figure 19. Fatigue Results for 410 Stainless Steel (Heat Treated) Specimens

The fatigue results for the 410 stainless steel in the heat-treated condition is shown in Figure 19. Again, as expected, the curve for machined crack specimens was lower than for the machined hole specimens; however, the slope for the specimens with the crack was much greater in value than for the specimen with the hole. This difference in the slope

appears to indicate that the heat-treated specimens with the machined crack are appreciately more sensitive to fatigue than the specimens with machined hole. This large difference in the value of the slope for the machined crack and hole specimens occurred only for this material. The other metal materials all had similar slopes for their specimens with cracks and holes.

The 410 stainless steel material in the heat-treated condition showed a marked improvement in fatigue strength compared to the annealed specimens. For the  $10^4$  cycle value,

stress levels of 86 and 103 ksi were received for the crack and hole specimens, respectively. A stress level of about 28 ksi was received for the crack specimens for the cycle level of  $10^5$  and 69 ksi for the hole specimens. Those heat-treated specimens exhibited the best response to fatigue of any of the metal materials. The material also appeared to be insensitive to fatigue for the hole specimens and somewhat sensitive to fatigue for specimens with a crack. Using the ranking system, a rating of 6.1 is received for the crack specimens and 9.5 for the hole specimens.

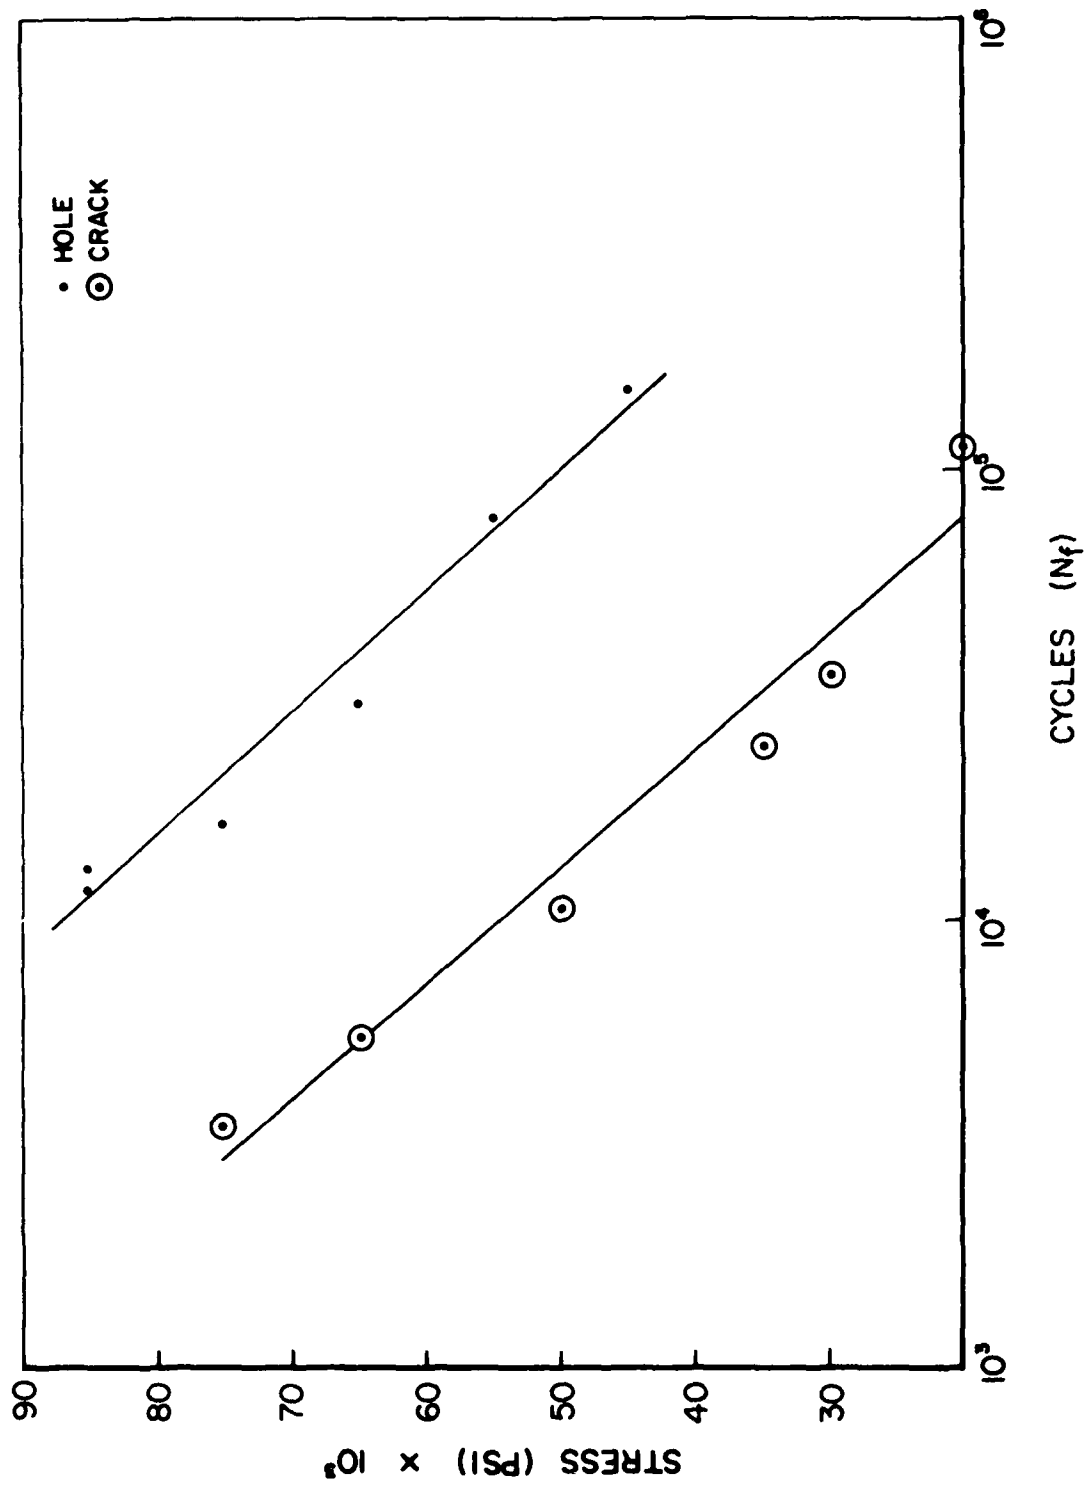
Figure 20. Fatigue Results for 6-4 Titanium Specimens

Figure 20 shows the fatigue results for the 6-4 titanium specimens. Again, the curve for the machined crack specimens is lower than for the machined hole specimens by about 33 ksi for the same number of cycles.

The 6-4 and 8-1-1 titanium materials exhibited a very similar response to fatigue. For the 6-4 titanium material, stress levels for the crack specimens of 54 and 20 ksi were received for the  $10^4$  and  $10^5$  cycle levels, respectively. For the specimens with a hole, stress levels at the  $10^4$  and  $10^5$  cycle values were 87 and 50 ksi, respectively. Based on the ranking system, ratings of 3.9 and 7.5 are received for the crack and hole specimens, respectively.

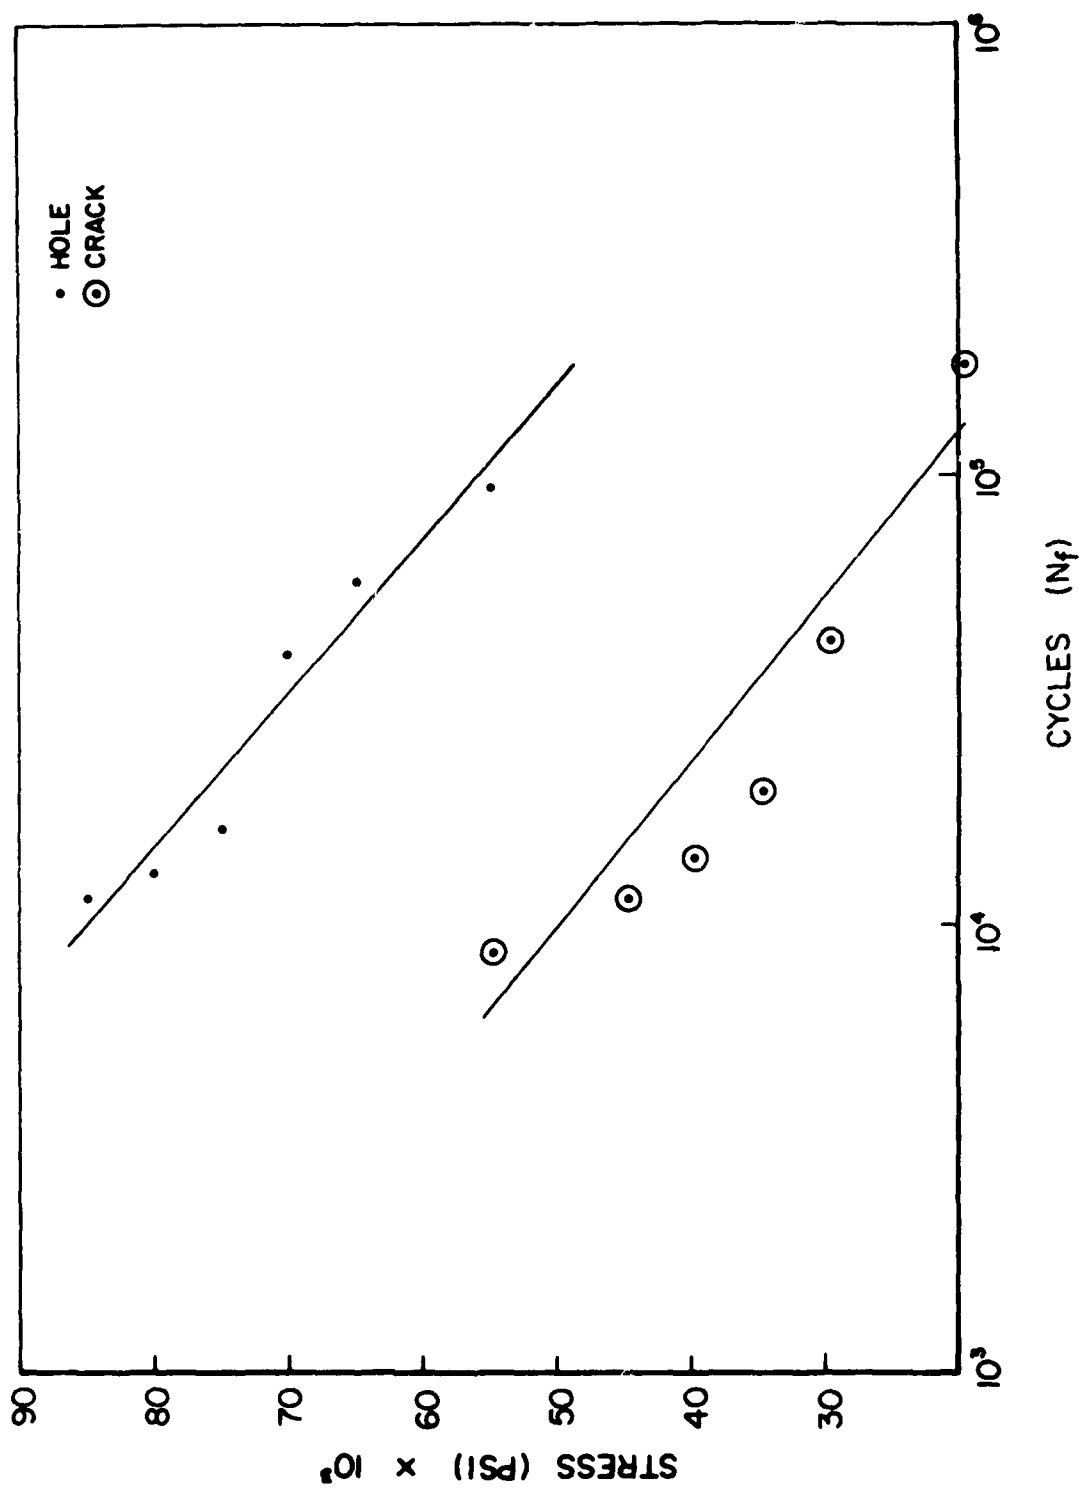
Figure 21. Fatigue Results for 8-1-1 Titanium Specimens

The fatigue results for the 8-1-1 titanium material was very similar to the 6-4 titanium specimens as shown in Figure 21. The spread in the curve for the machined crack specimens was about 33 ksi lower than for the machined hole specimens.

The 8-1-1 titanium had stress levels of 50 and 23 ksi for the crack specimens at the cycle levels of  $10^4$  and  $10^5$ , respectively. The stress levels for the hole specimens was 85 and 56 ksi at the  $10^4$  and  $10^5$  cycle levels, respectively. Based on this information, ratings of 3.9 and 7.7 are received for the crack and hole specimens, respectively.

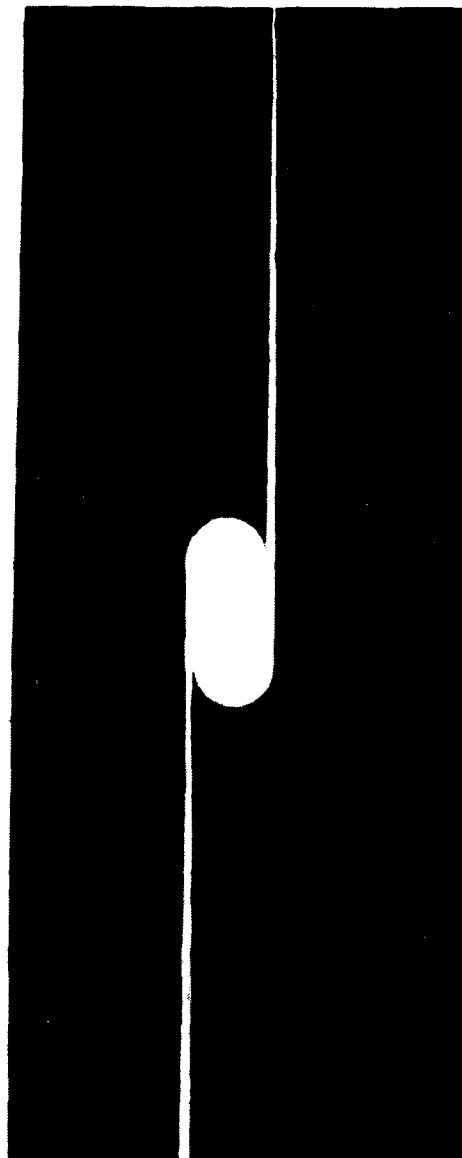
Figure 22. Longitudinal Cracks Developed on Graphite/  
Epoxy Specimen Upon Dynamic Load Application  
in Fatigue Testing

the endurance limit at  $10^5$  cycles is above 70 ksi for the graphite/epoxy material. On the specimens with machined cracks, longitudinal cracks occurred when the dynamic load was applied and these cracks continued to grow until the test was stopped. The tests on the machined hole specimens was stopped when cracks became visible which ran across the width dimension of the specimens. Figure 22 shows these longitudinal cracks on a typical graphite/epoxy specimen.
